ADDIS ABABA SCIENCE AND TECHNOLOGY UNIVERSITY

Assessment of Asphalt Road Defects and Maintenances in Addis Ababa

Desta Eshete

January /2017

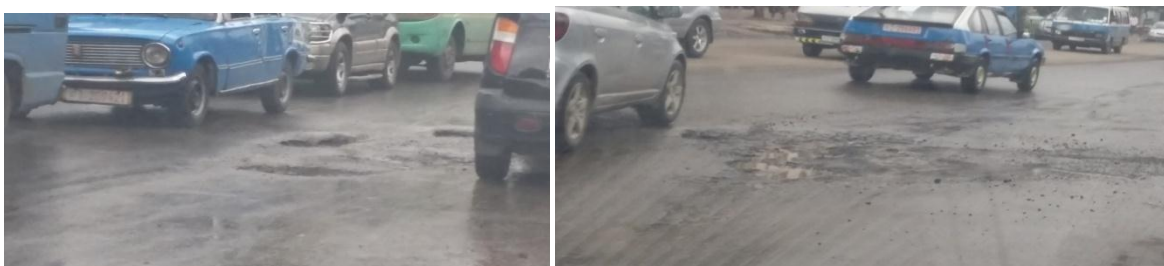
Figure-19 Photo courtesy of AACRA Pot holes high severity and low extent

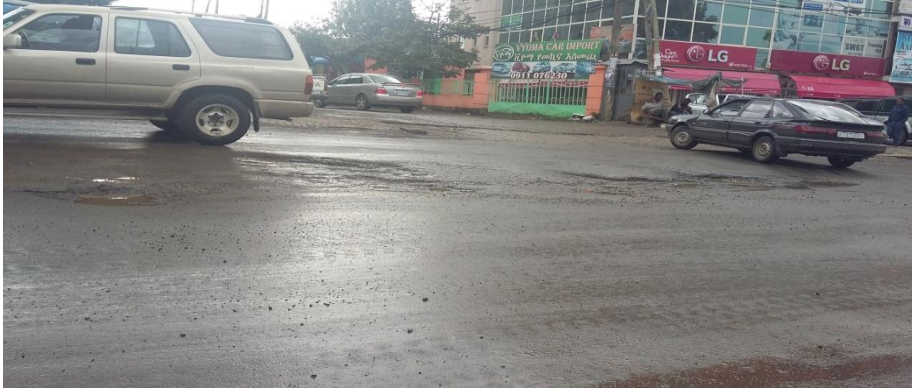
Figure-20 Photo courtesy of AACRA Potholes of high severity and extent

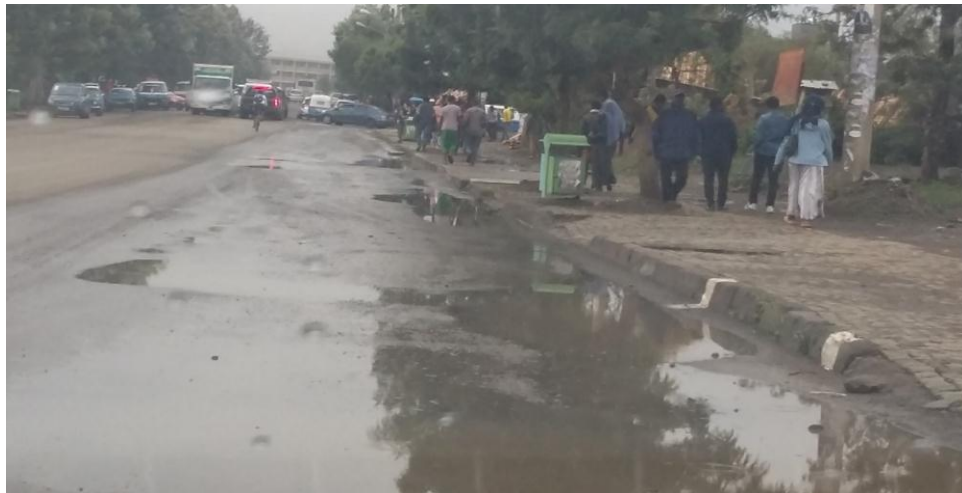
On some part of this road the drainage line and manhole gutters are functional but the surface water on the asphalt pavement could not directed towards the manhole due to slope problem of the road , this can be best illustrated on figure-21 & 26.

Figure-21 Photo courtesy of AACRA Slope and crown problem of the road for stagnation of rain water

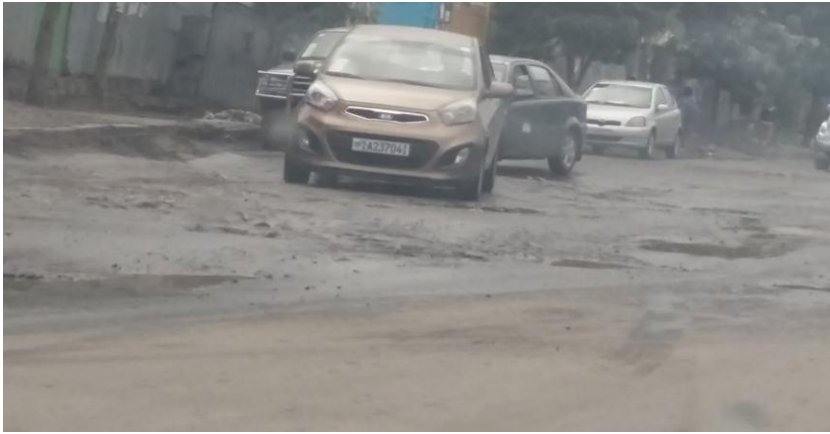
Figure-22 Photo courtesy of AACRA Surface damage of asphalt due drainage blockage

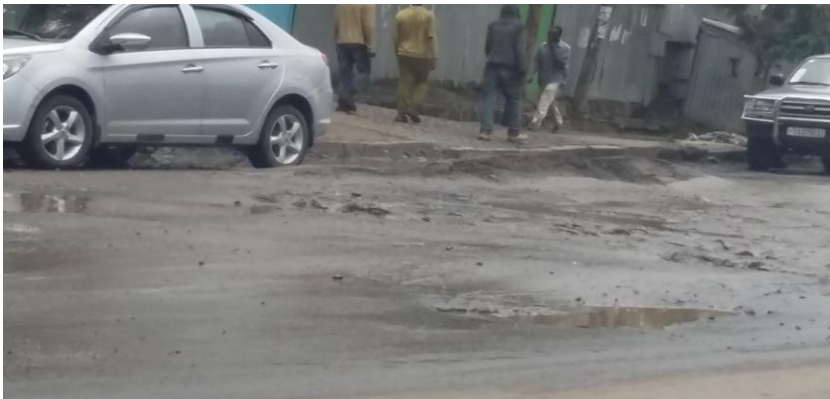
Figure-23 Photo courtesy of AACRA Surface damage due to drainage blockage and cambering problem

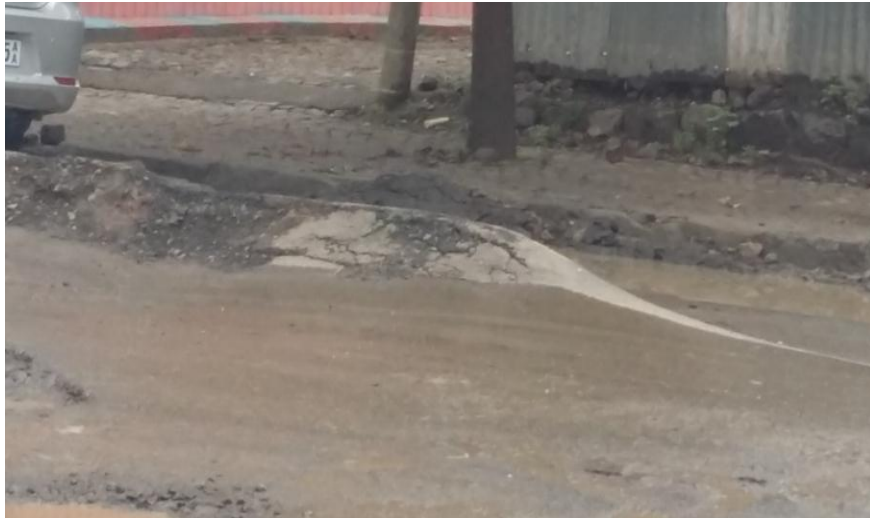
Figure-24 Photo courtesy of AACRA, Structural damage of the road due to penetration of the stagnant water on pot hole of high severity and extent

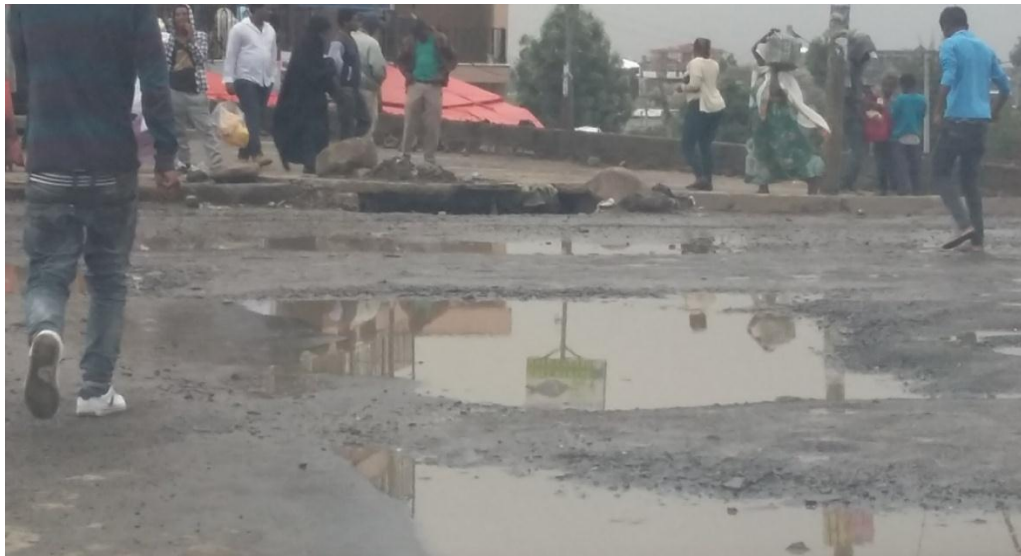
Figure-25 Photo courtesy of AACRA, Pot hole of high severity and extent and also slope problem of the crown

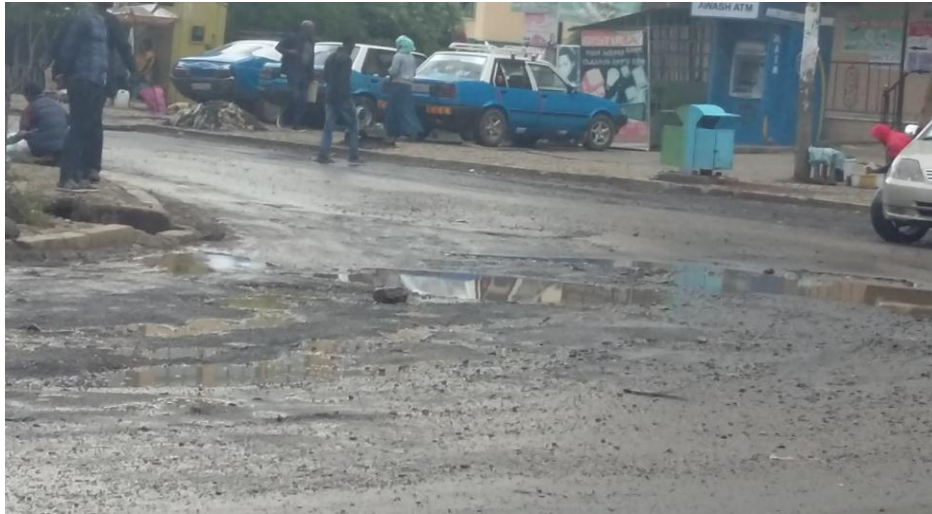
Figure-26 Photo courtesy of AACRA, pot hole and asphalt surface damage and slope problem around Gerji

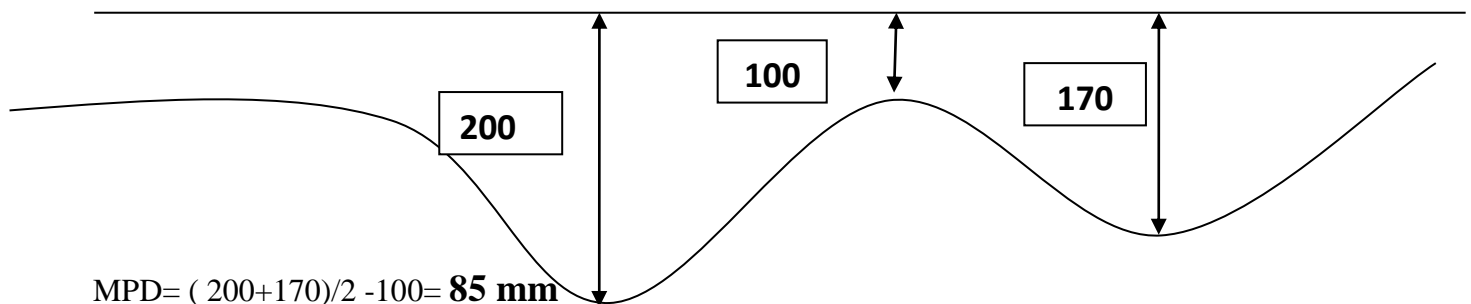
Figure-29 Rutted road section depth measurement

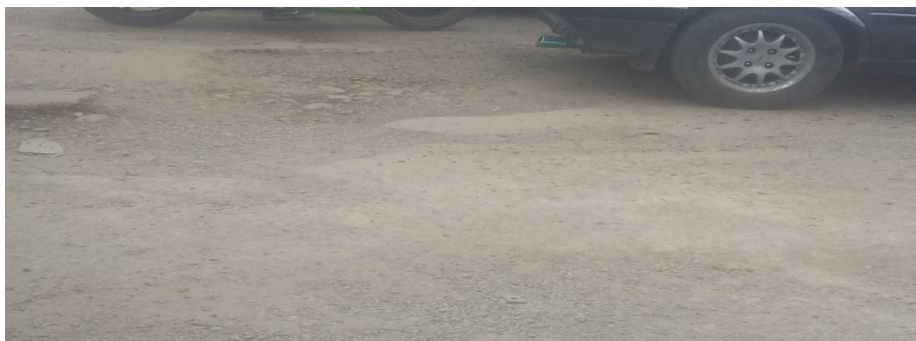
Figure-27 Photo courtesy of AACRA Potholes of high severity around Kera Total fuel station

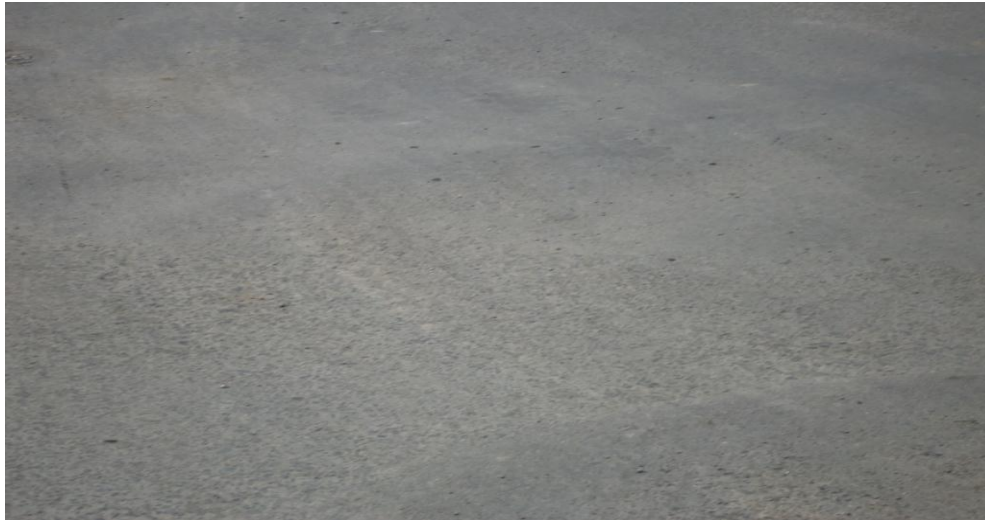
Figure-28 Photo courtesy of AACRA Potholes of high severity around Kera Total fuel station

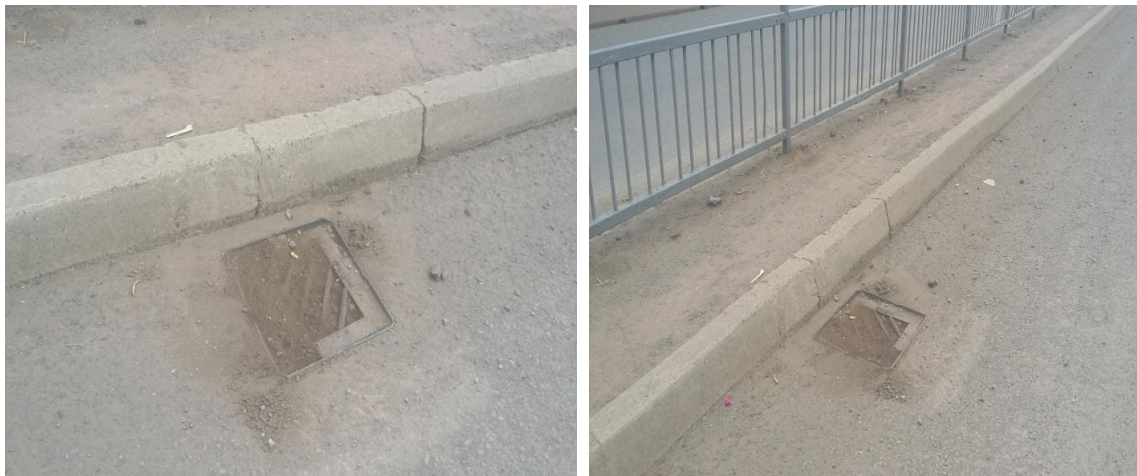
Figure-1 Photo courtesy of AACRA Blocked Manhole gutter

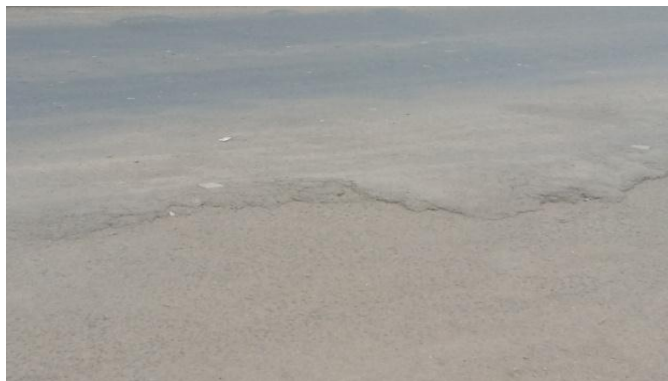
Figure-2 Photo courtesy of AACRA Patch deterioration from Hana Mariam to Kality Road and Transport authority outer lane Ring road

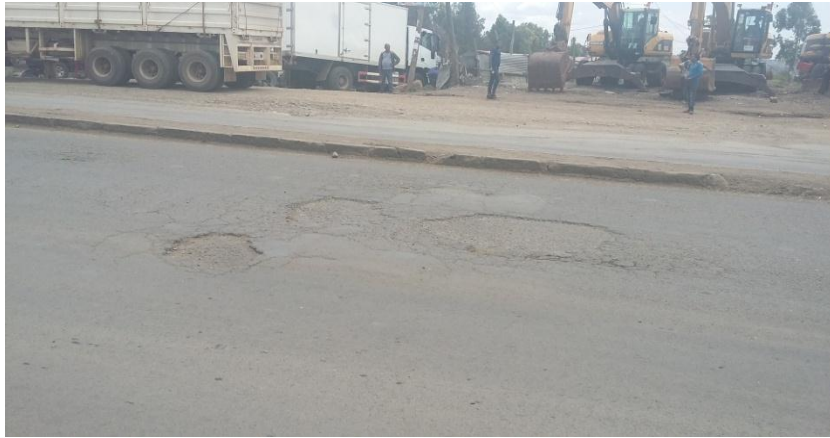
Figure-3 Photo courtesy of AACRA Propagation of block cracking to pot hole around Kality Road and Transport

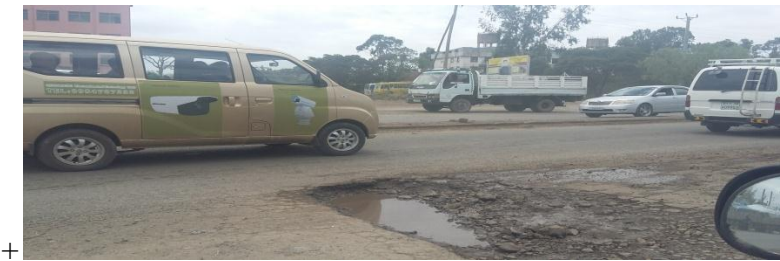
Figure-4 Photo courtesy of AACRA Pot hole drainage and slope problem around Kality Road &Transport authority

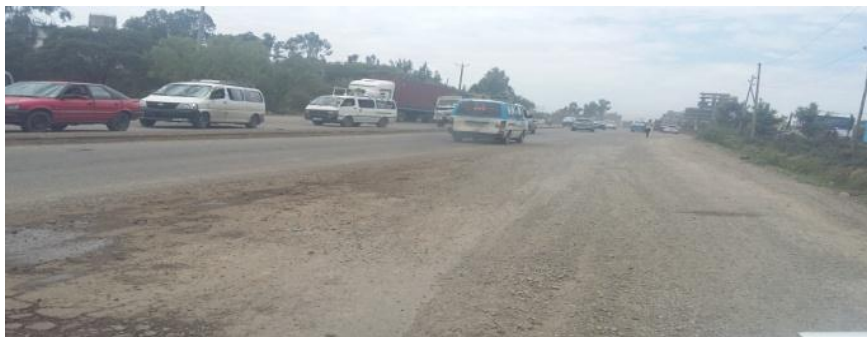
Figure-5 Photo courtesy of AACRA around Kality Weha Limat Shoulder damage, Slope problem and Drainage problem

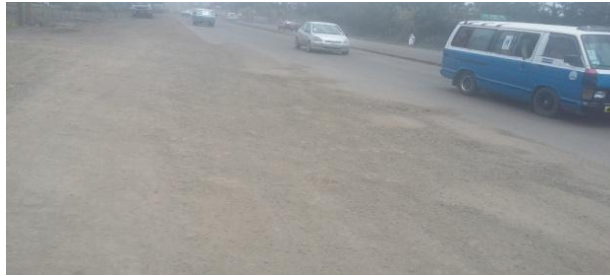
Figure-6 Photo courtesy of AACRA around Kality Weha Limat Slope or cambering problem and no Drainage at all

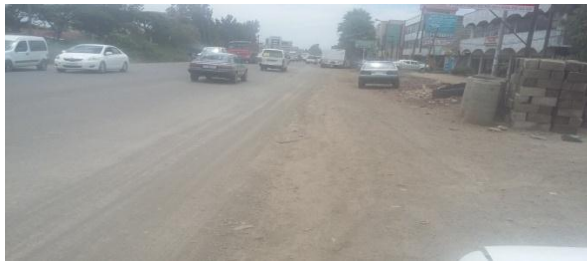
Figure-7 Photo courtesy of AACRA the road around Korki factory with out drainage and shoulder damage

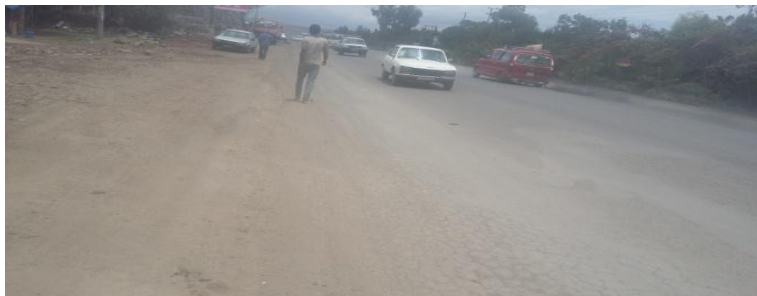
Figure-8 Photo courtesy of AACRA the road around Korki factory with camber problem and the shoulder level above the road level with no drainage.

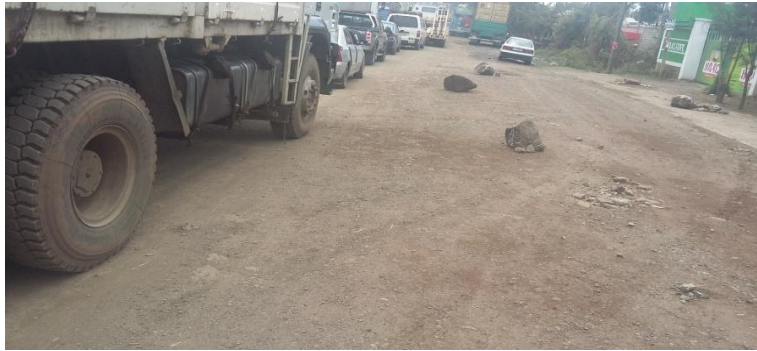
shoulder as observed on figure-9,11, 16 & 17and also registered on condition survey data sheet table-5. In general the road surface on this section is completely and severely damaged.

Figure-9 Photo courtesy of AACRA The road section from Kality Sheger Building to Kality Crown Hotel completely damaged road with drainage blocked by damage and culvert slab with no access for surface run off entrance and camber problem.

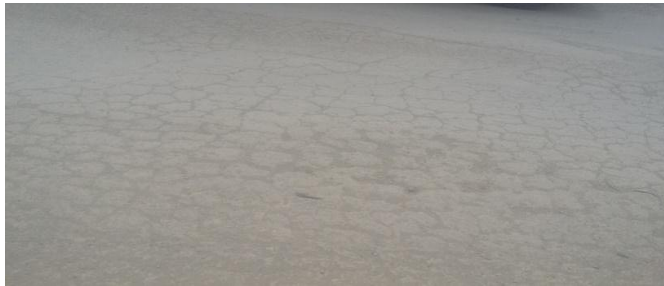
Figure-10 Photo courtesy of AACRA Aging of asphalt on the road section from Kality Road and Transport authority to Kality Sheger building

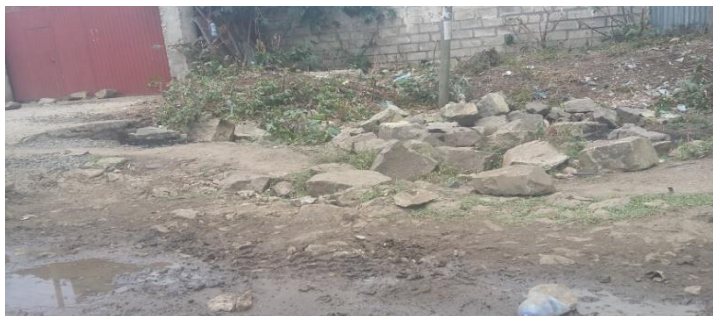
Figure-11 Photo courtesy of AACRA Drainage damage and blockage on the road section from Kality Sheger Building to Crown Hotel

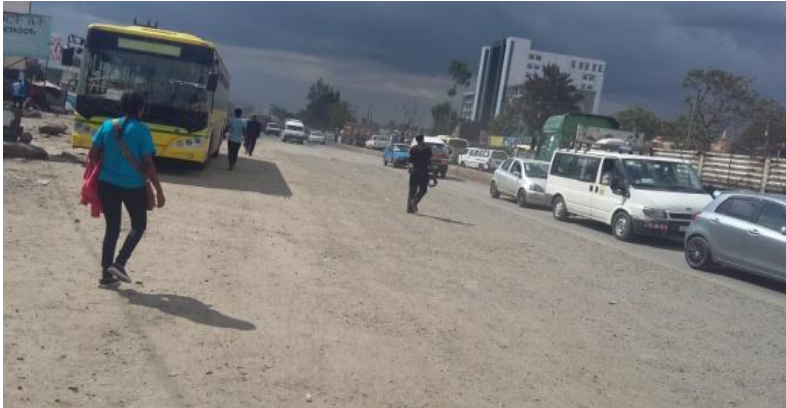
Figure-12 Photo courtesy of AACRA Surface damage around Kaliti Total due to Lack of drainage and cambering problem

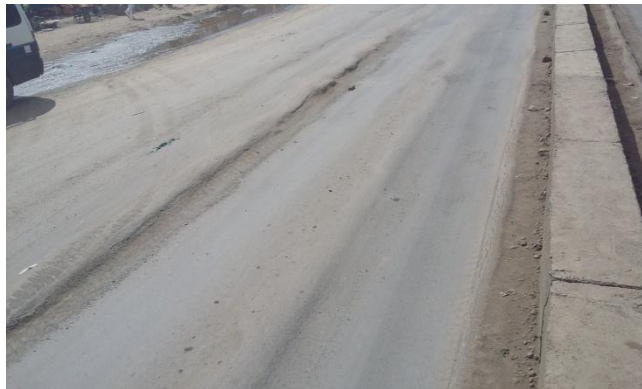
Figure-13 Photo courtesy of AACRA Rutting of high severity, Structural damage, Shoulder damage and lack of drainage around Kaliti Total

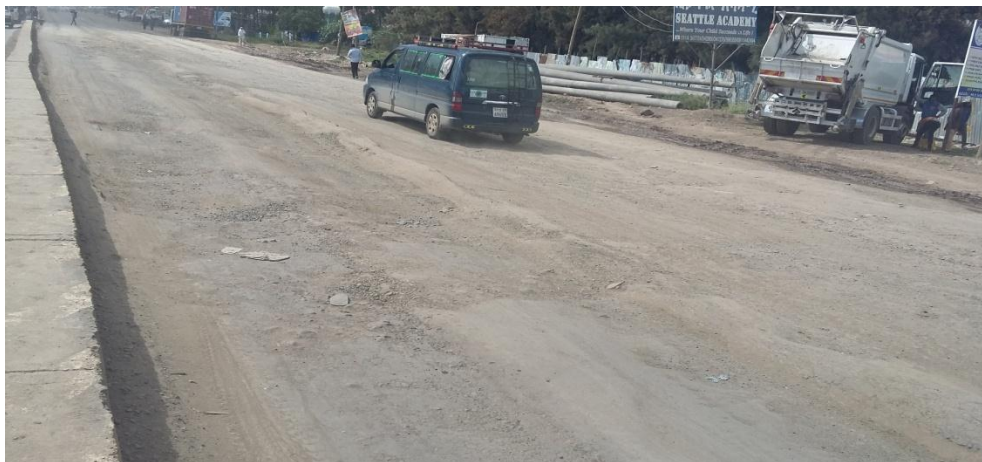
Figure-14 Photo courtesy of AACRA Complete Road Structural damage, Rutting of high severity Cambering problem Shoulder level above road level and lack of drainage provision around Kality Total.

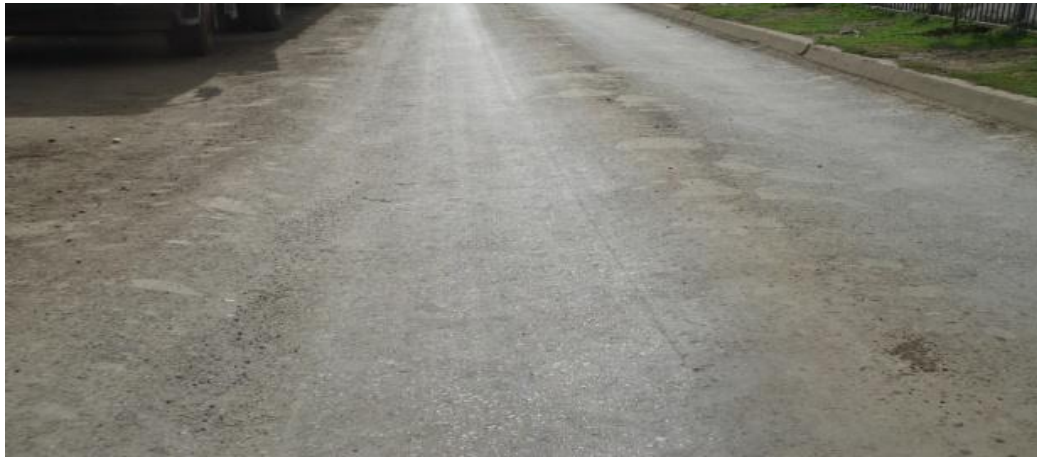
Figure-15 Photo courtesy of AACRA Rutting and shoving of high severity and cambering problem on the road that directs from Hana mariam to Kality Road & Transport Square on the outer lane of ring road.

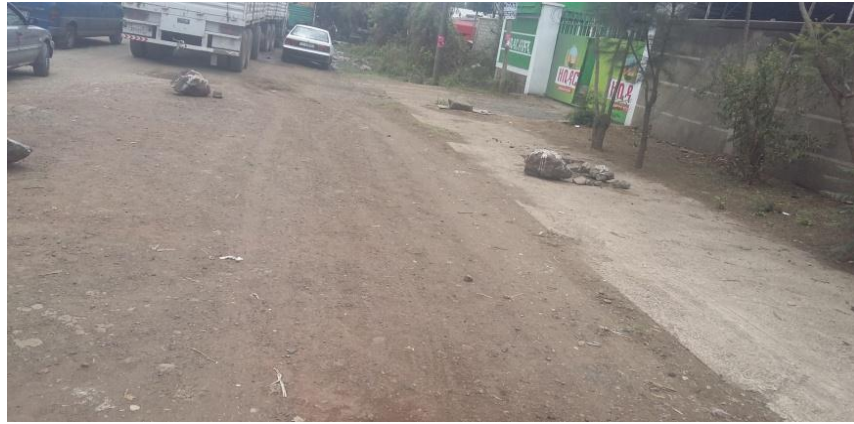
Figure-16 Photo courtesy of AACRA Drainage blockage, cambering problem and also surface damage of the road section from kaliti Sheger building to Crown Hotel

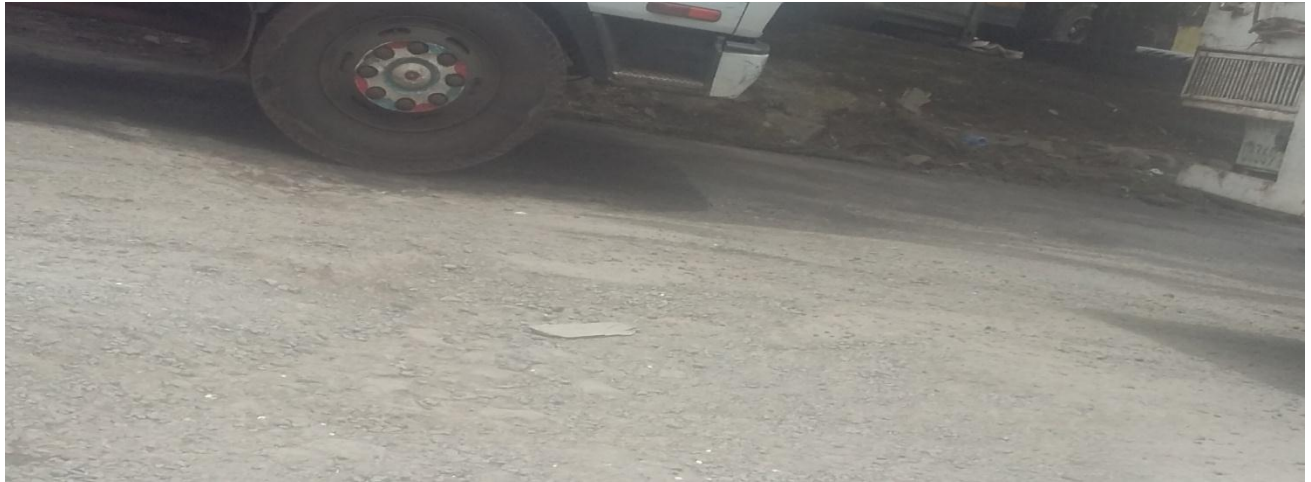
Figure-17 Photo courtesy of AACRA Complete damage of the road section from Kality Sheger building to Kality crown Hotel.

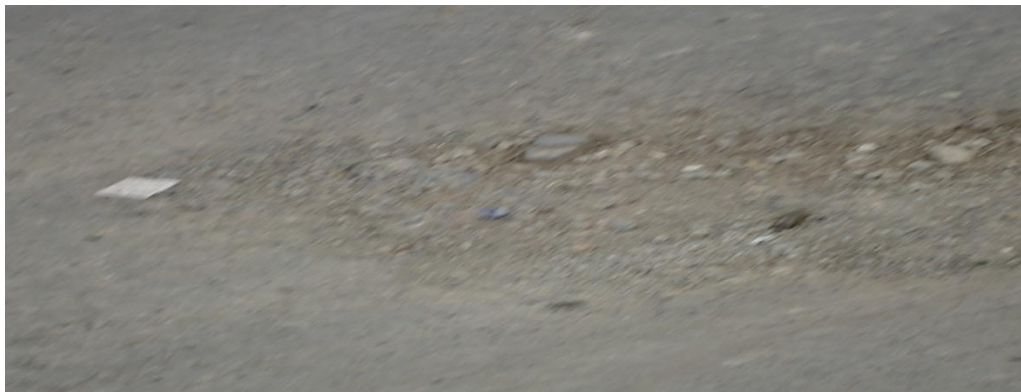
Figure-18 Photo courtesy of AACRA pot hole and asphalt surface damage around Hana mariam over pass bridge
